# HERTING RIVERBANK STABILIZATION ISANTI, MN

Isanti SWCD

Riverbank Stabilization

## Project Summary

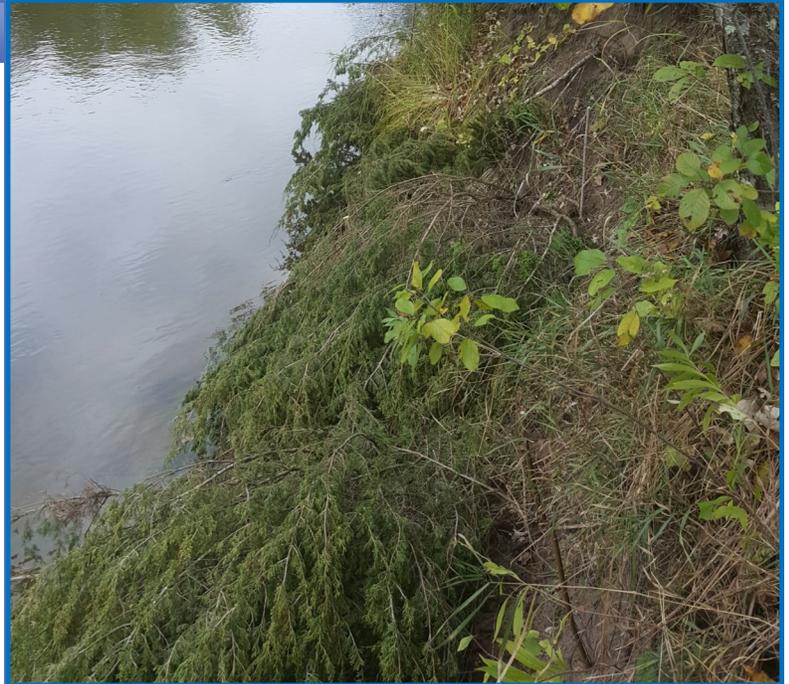
Completed project in the fall of 2018.

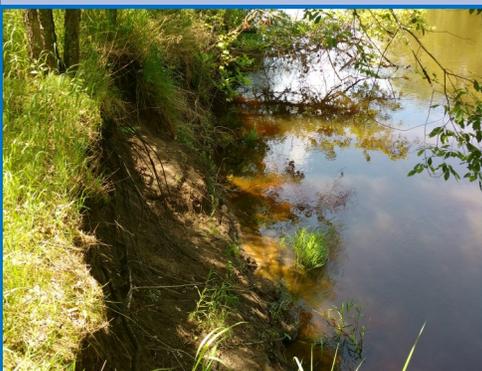
Pre-stabilization conditions consisted of an actively eroding riverbank and sparse understory vegetation. Bare soil and exposed tree roots were clearly visible.
