# Agenda

# Skogman Lake Study

# Skogman Lake Shoreline Data

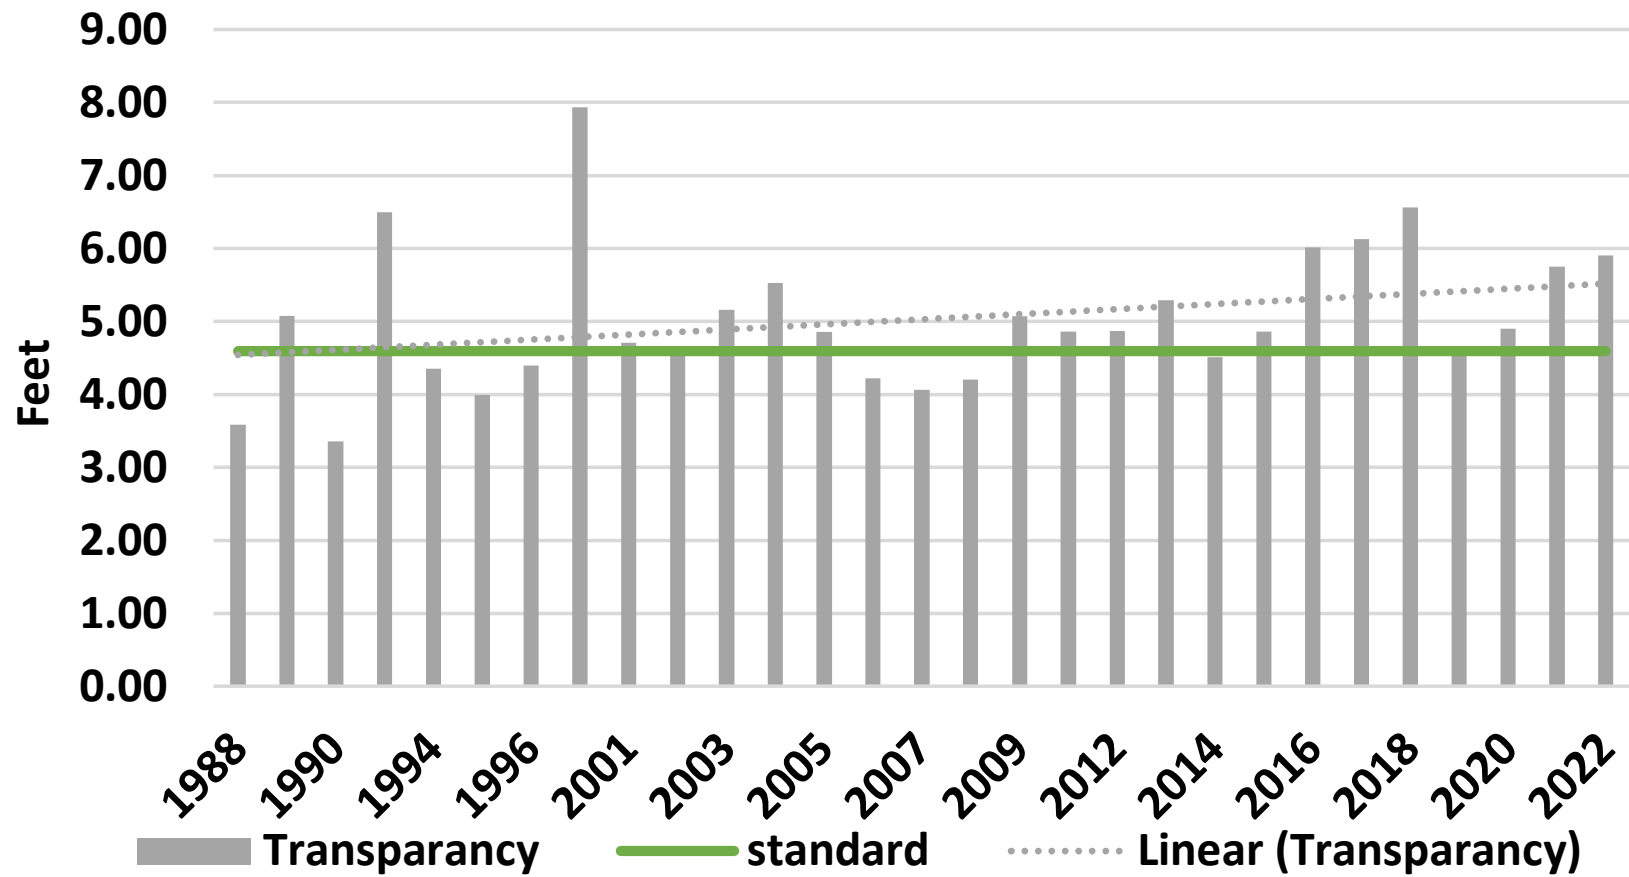
## Growing Season Transparency

- Transparency data recorded since 1988
- 2022 Lake Monitoring: Phosphorus, Chlorophyll-a and Transparency 2x a Month
- 2022 Stream Monitoring: Phosphorus, sediment and transparency 8 times a growing season.
- 2023 Repeat

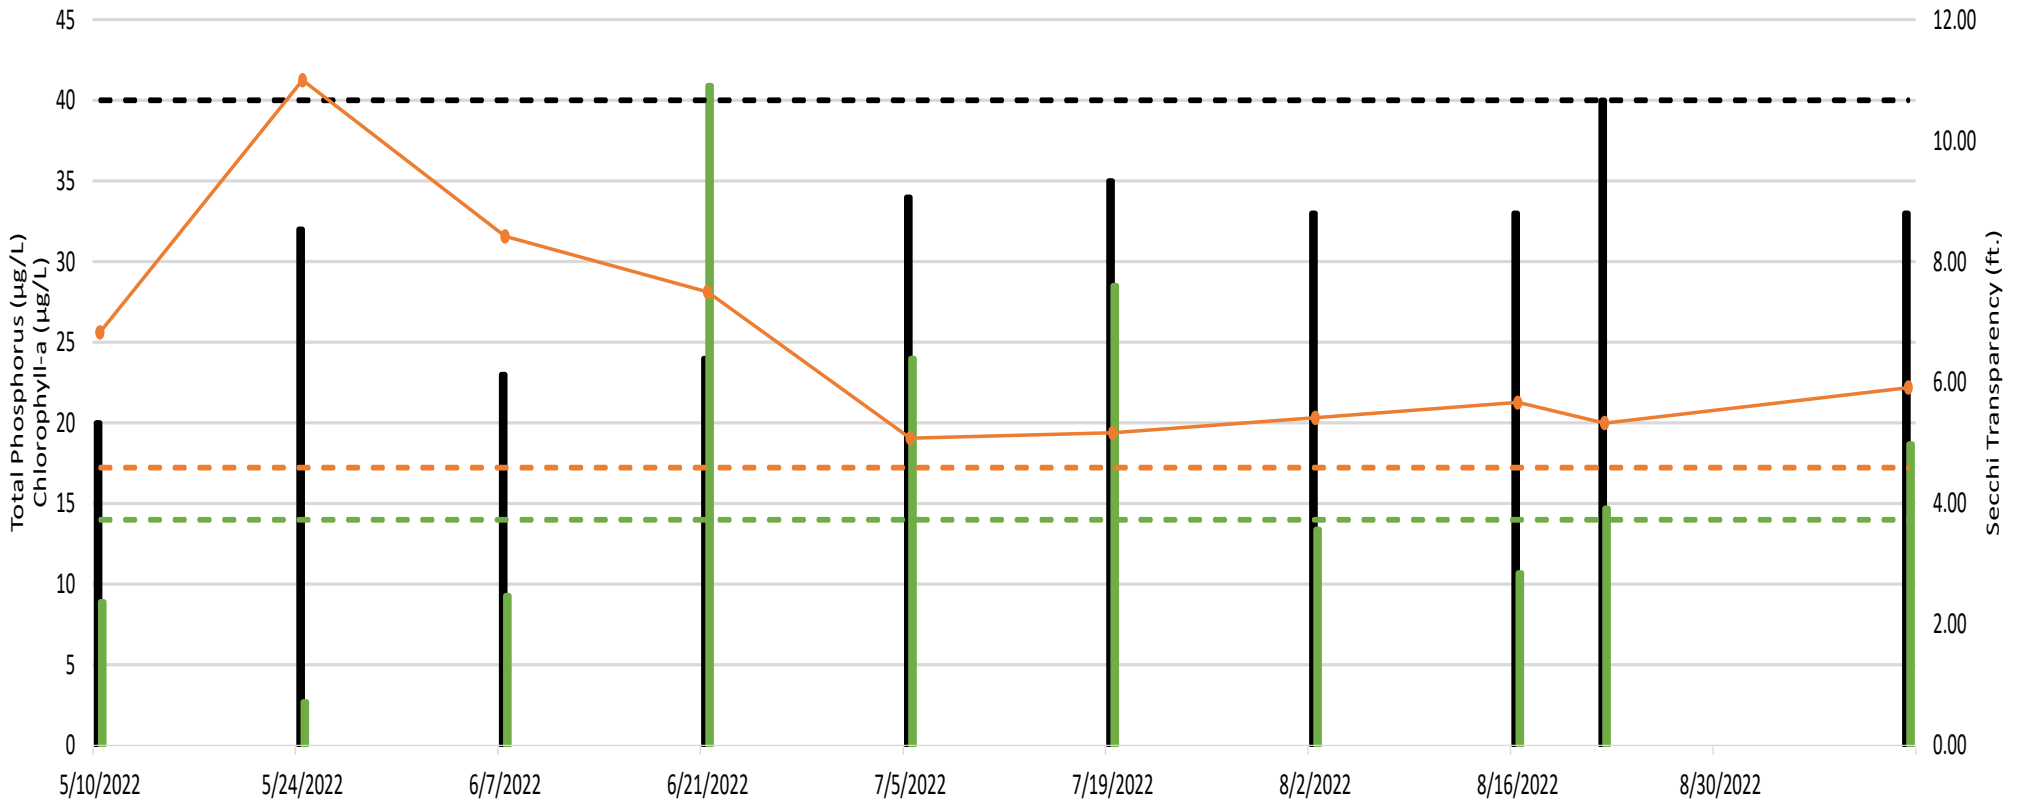
2022

Total Phosphorus (µg/L) Chlorophyll-A (µg/L) Secchi Transparency (ft)

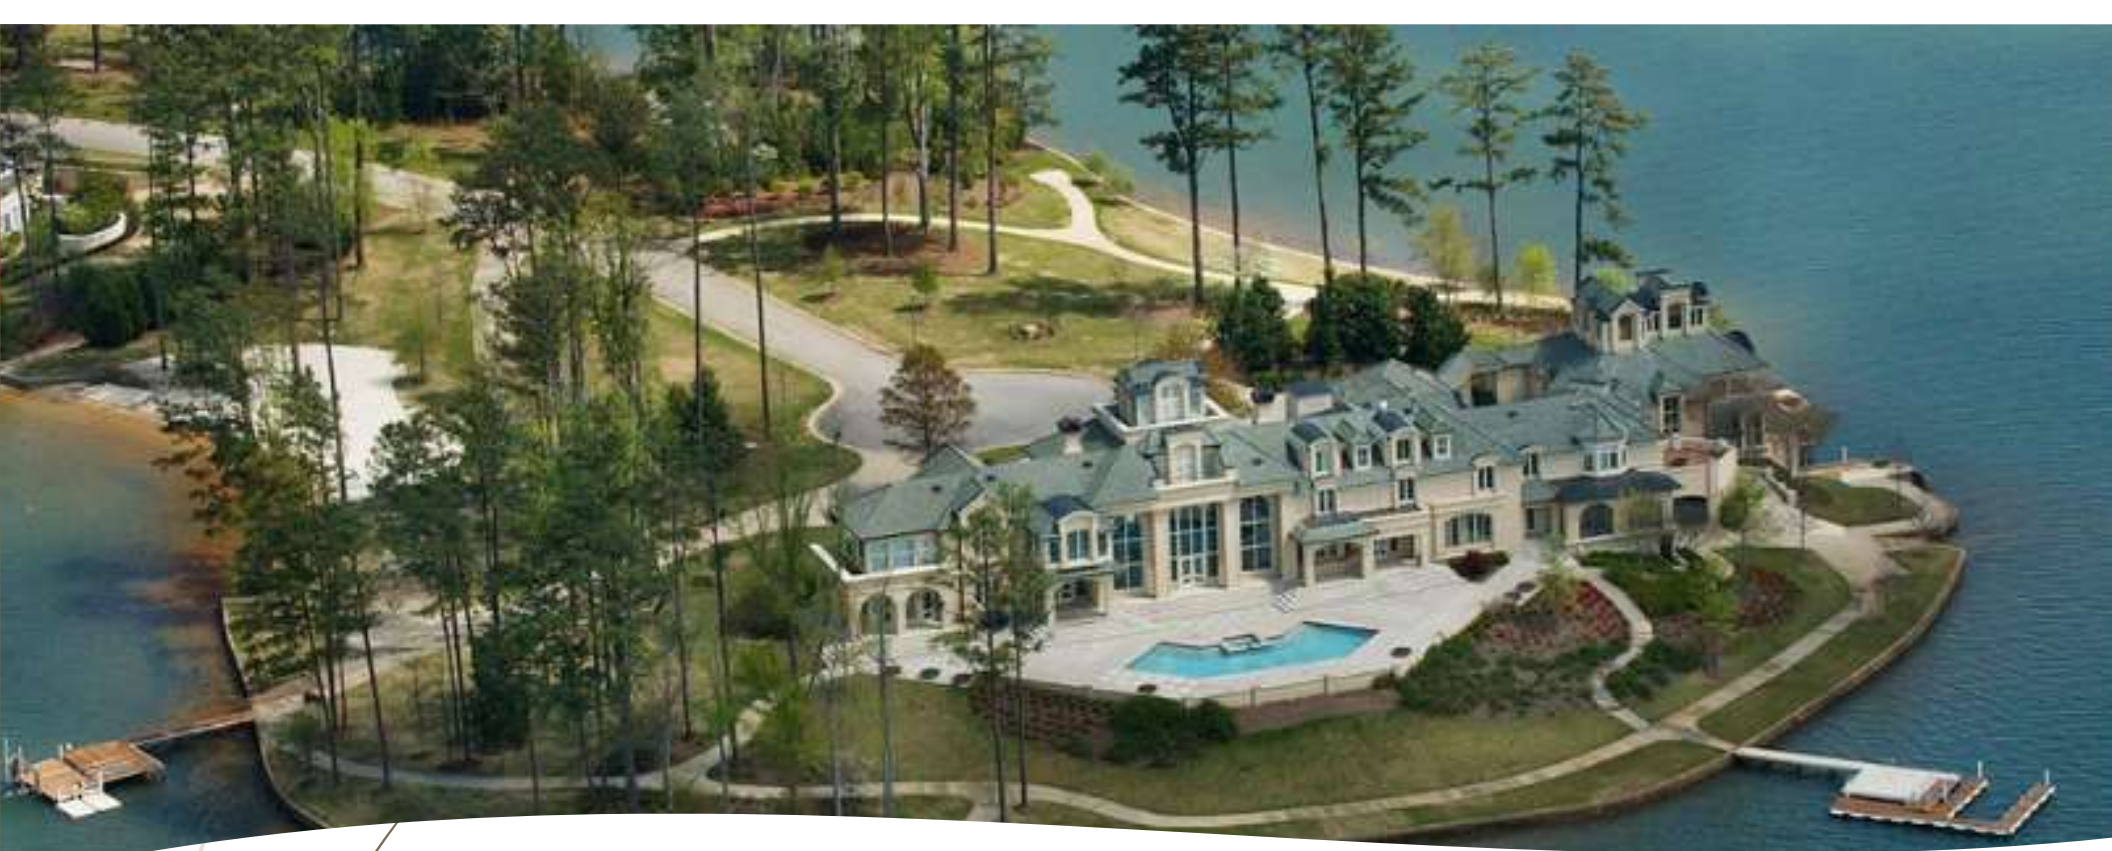
- 6.1 miles of shoreline.
- Plenty of RipRap (rock along shoreline)
- Manicured turf grass.
- Slope.
- Residential development.
- Shoreline erosion
- Runoff concerns
- An estimated 3,467 linear feet were identified as potential restoration locations.

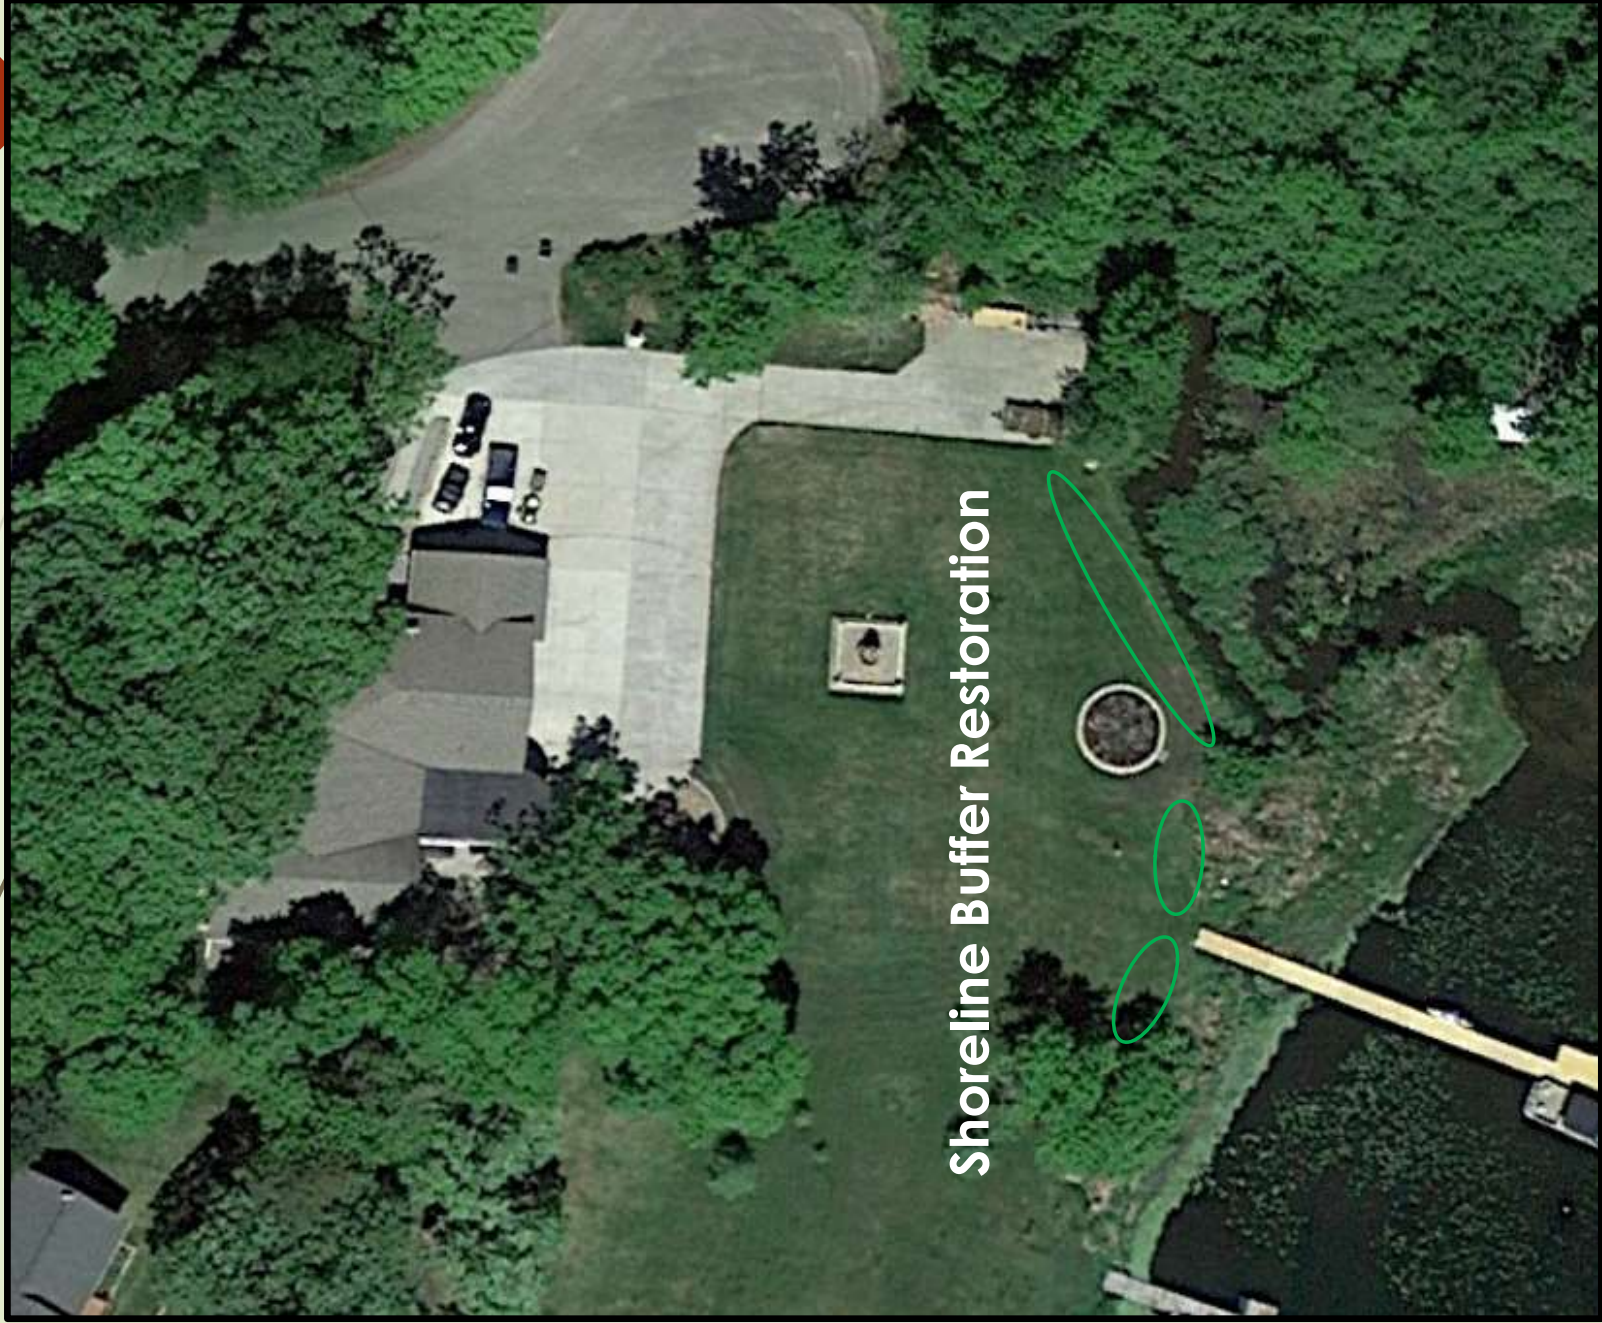
### **Impervious surface**

- Driveways
- Roofs
- Patios
- Walkways

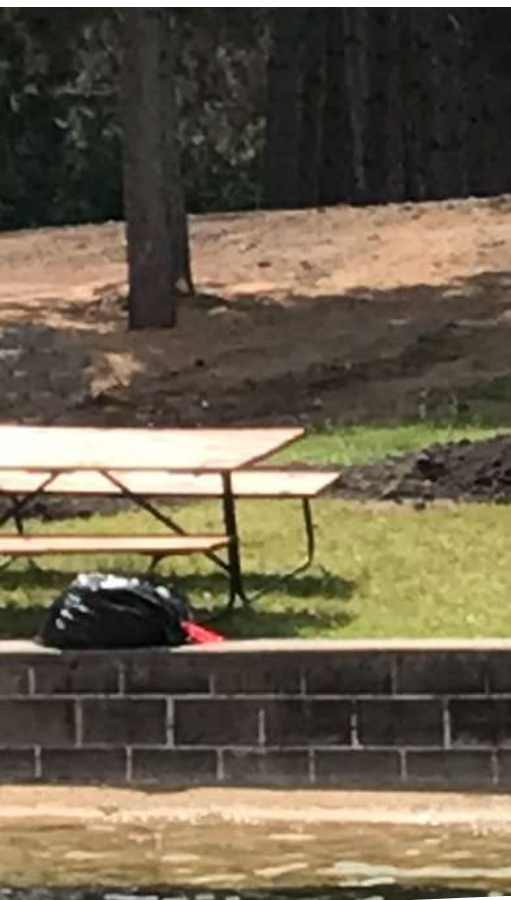
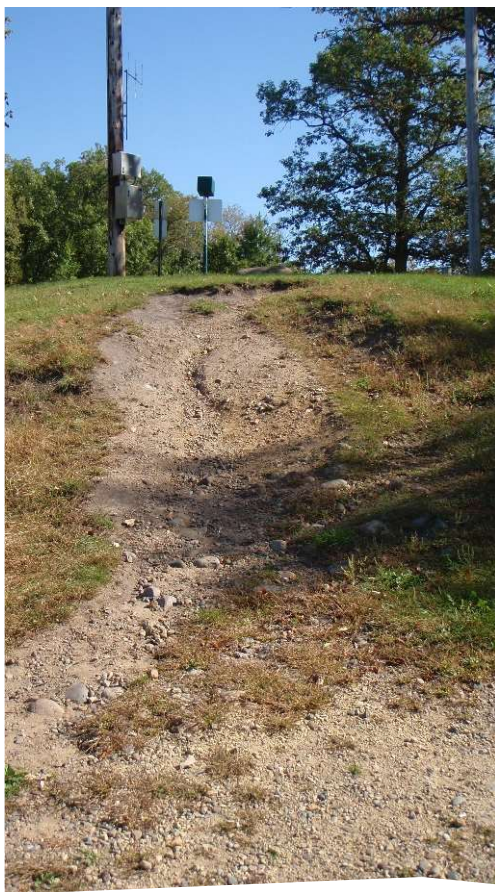
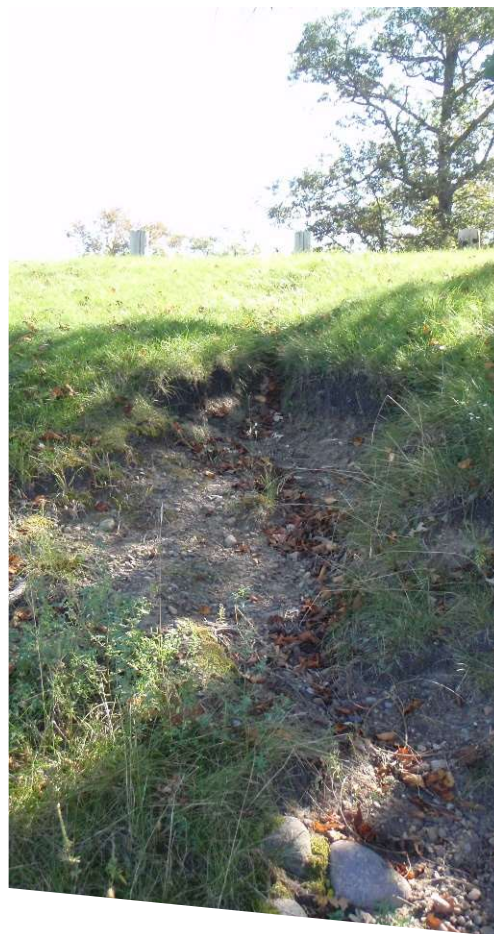
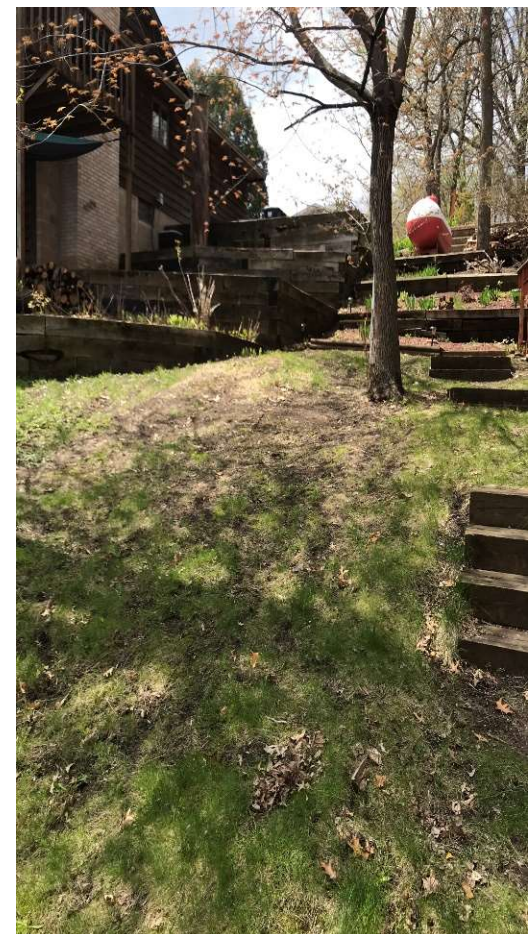
### **Slope to the lake:**

- Moderate Slope
- Steep Slope
- Manicured Lawn

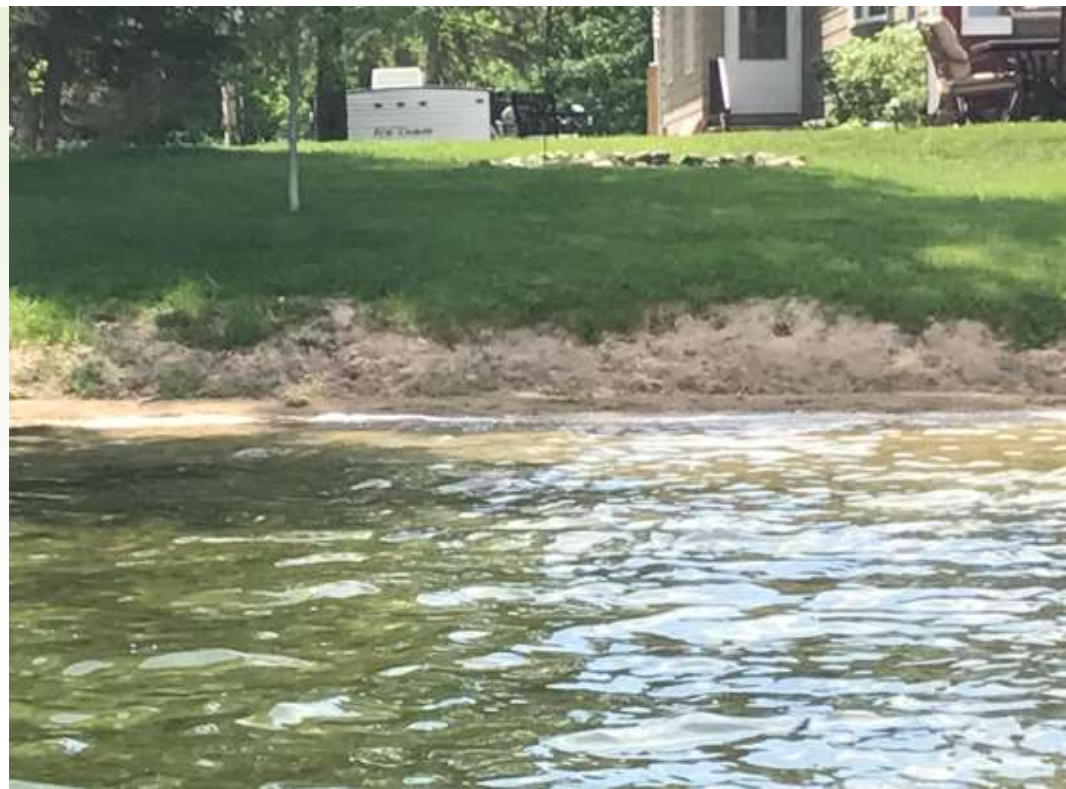
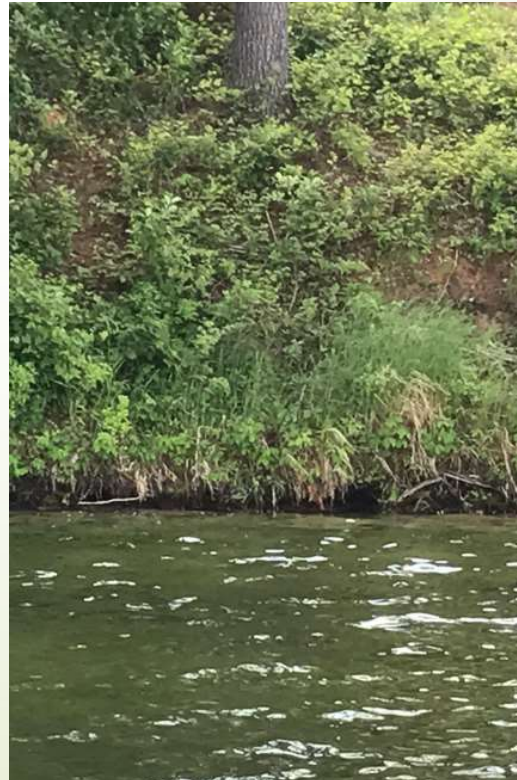
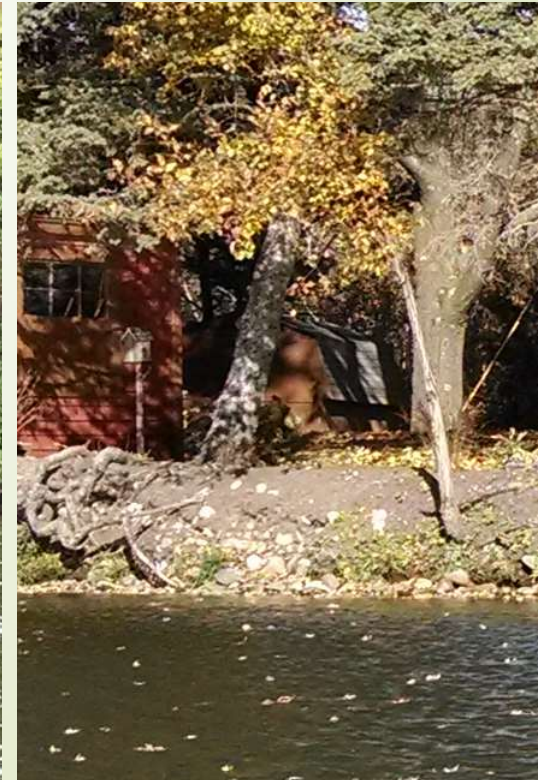
### Shoreline Erosion:

- Vertical banks
- Bare soil
- Maintained lawn
- Undercutting

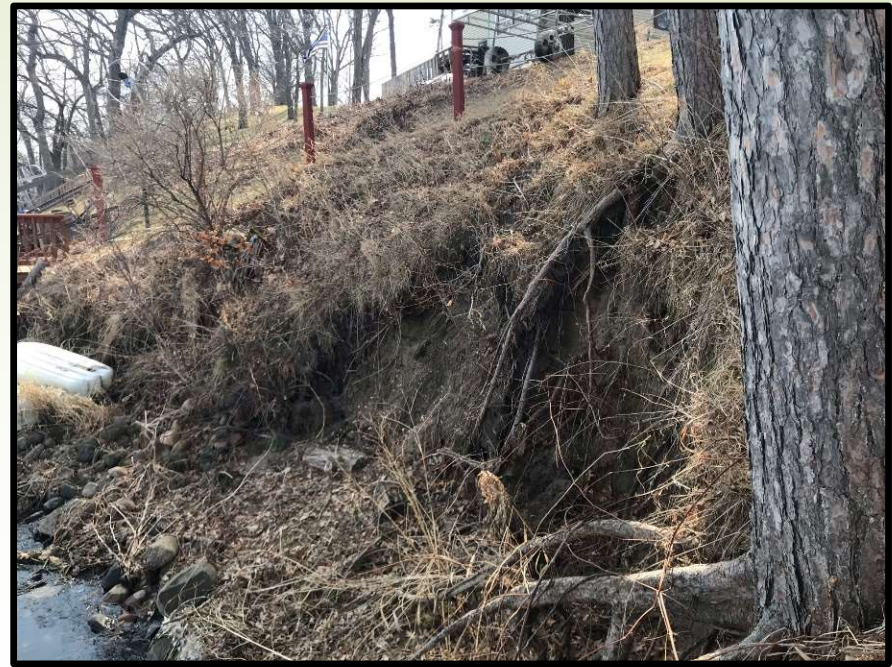
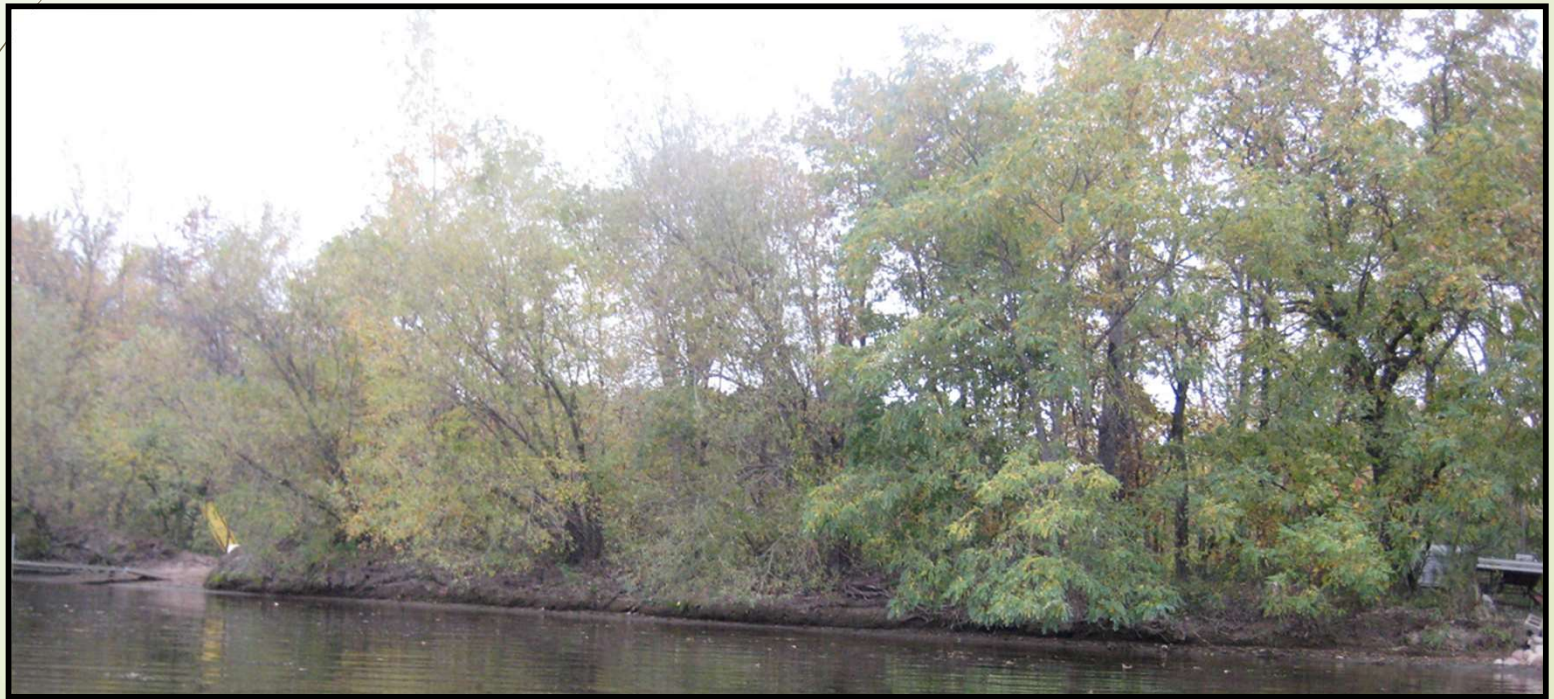
### Complex Shoreline Restoration:

- Severe erosion
- Difficult site access
- Large drainage area

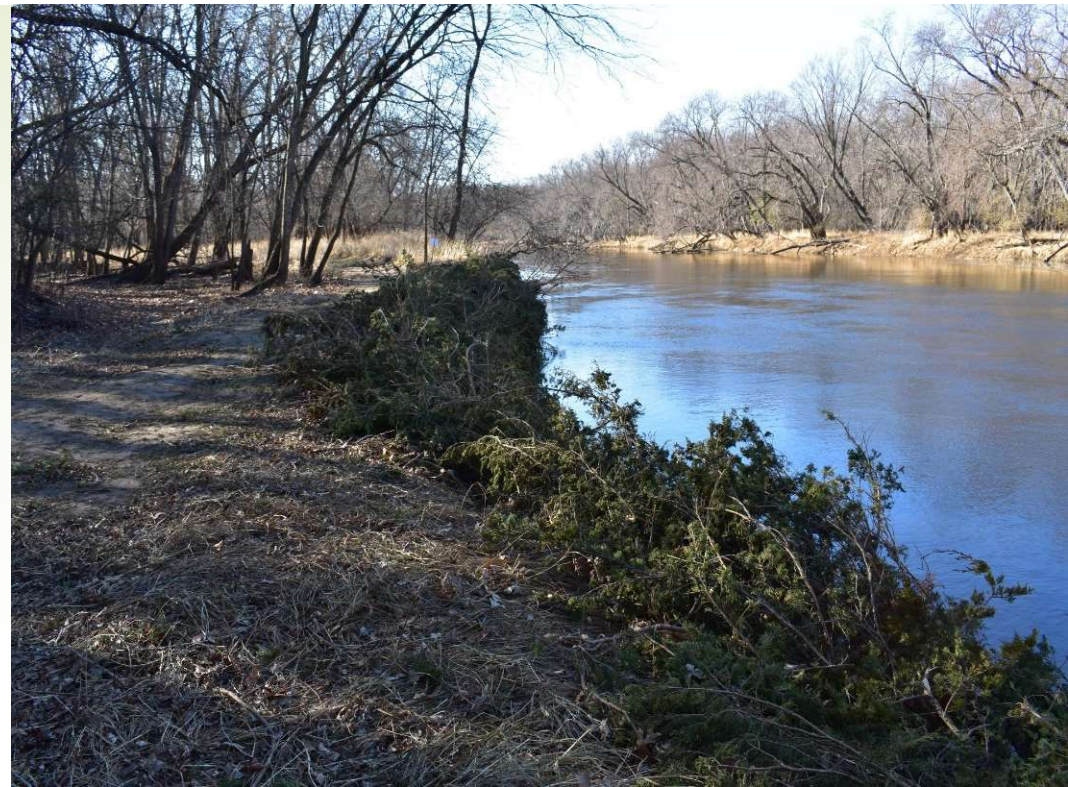
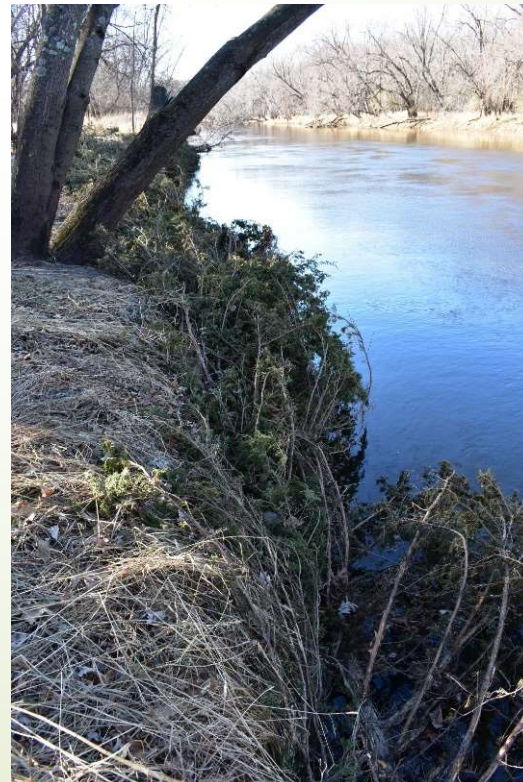
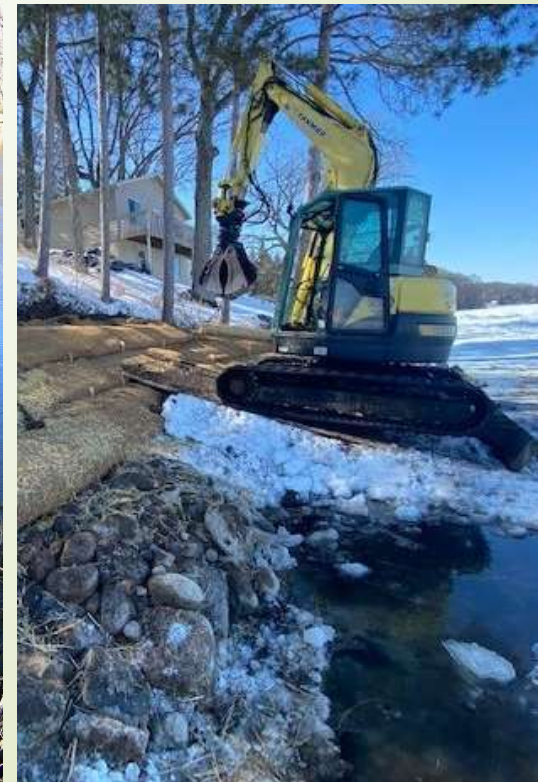
- Complex Shoreline Restoration:
- Certified engineered designs
- Surveying
- Permitting
- Heavy equipment contractor

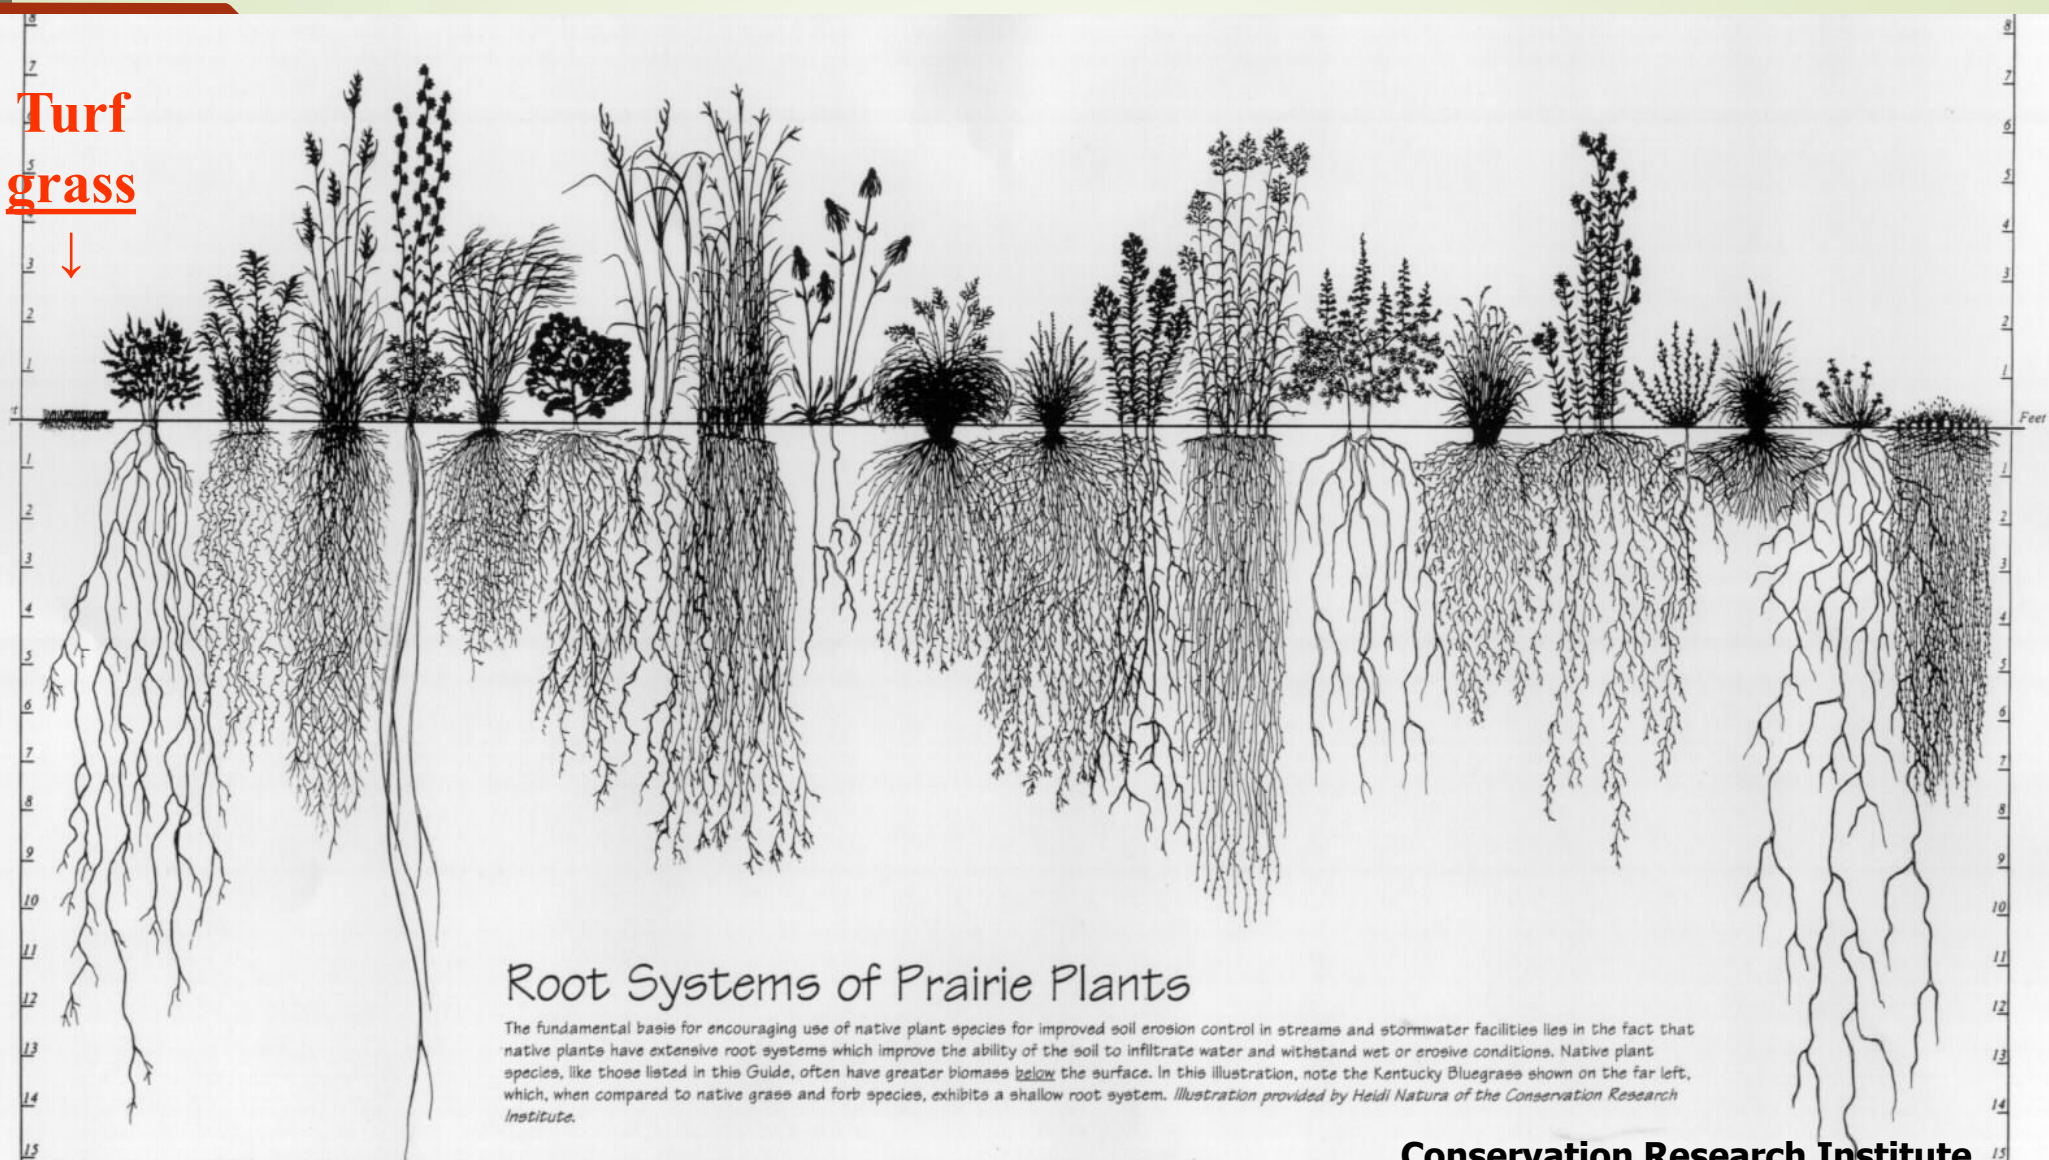
### Root Systems of Prairie Plants

The fundamental basis for encouraging use of native plant species for improved soil erosion control in streams and stormwater facilities lies in the fact that native plants have extensive root systems which improve the ability of the soil to infiltrate water and withstand wet or erosive conditions. Native plant species, like those listed in this Guide, often have greater biomass below the surface. In this illustration, note the Kentucky Bluegrass shown on the far left, which, when compared to native grass and forb species, exhibits a shallow root system. Illustration provided by Heidi Natura of the Conservation Research Institute.
