# **SCHURBON RIVERBANK STABILIZATION** CAMBRIDGE, MN

Riverbank Stabilization

### Project Summary

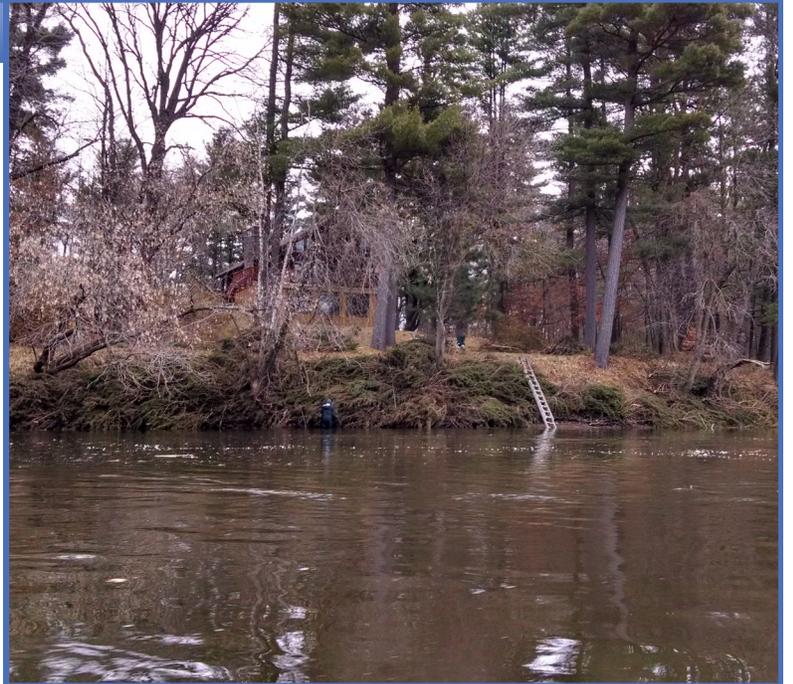
An additional 120 feet of revetment was installed in 2018

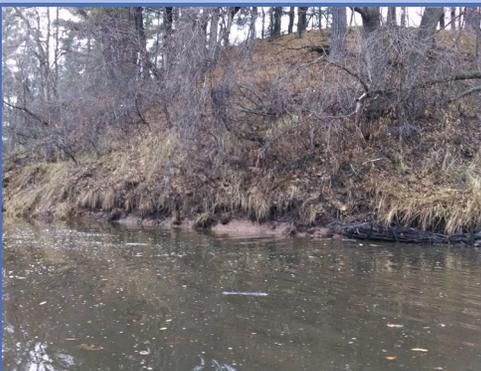
Pre-stabilization conditions consisted of an actively eroding riverbank and sparse understory vegetation. Bare soil and exposed tree roots were becoming clearly visible.

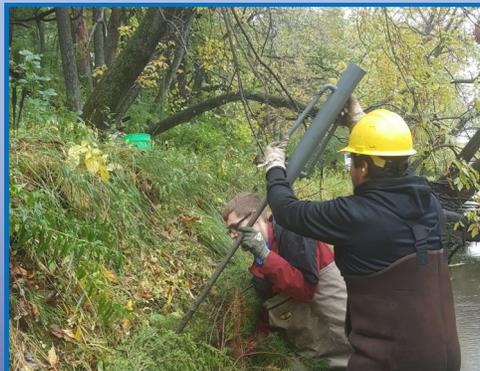
Cedar trees were tied together using cable and cable clips. The trees were then secured to the riverbank using a duckbill anchor with the trunks facing upstream to divert the flow of water away from the bank.

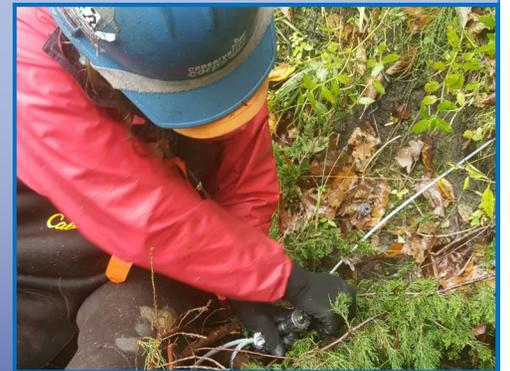
The cedar trees were anchored parallel to the shoreline and willow stakes were added between the trees. Willow stakes will grow and spread into a shrub grove to provide long lasting bank protection and habitat.
